USAAVLABS TECHNICAL REPORT 65-68

GROUND AND FLIGHT TESTS,  
XV-9A HOT CYCLE RESEARCH AIRCRAFT

C. W. Pieper

SUMMARY REPORT  
HTC-AD 65-13

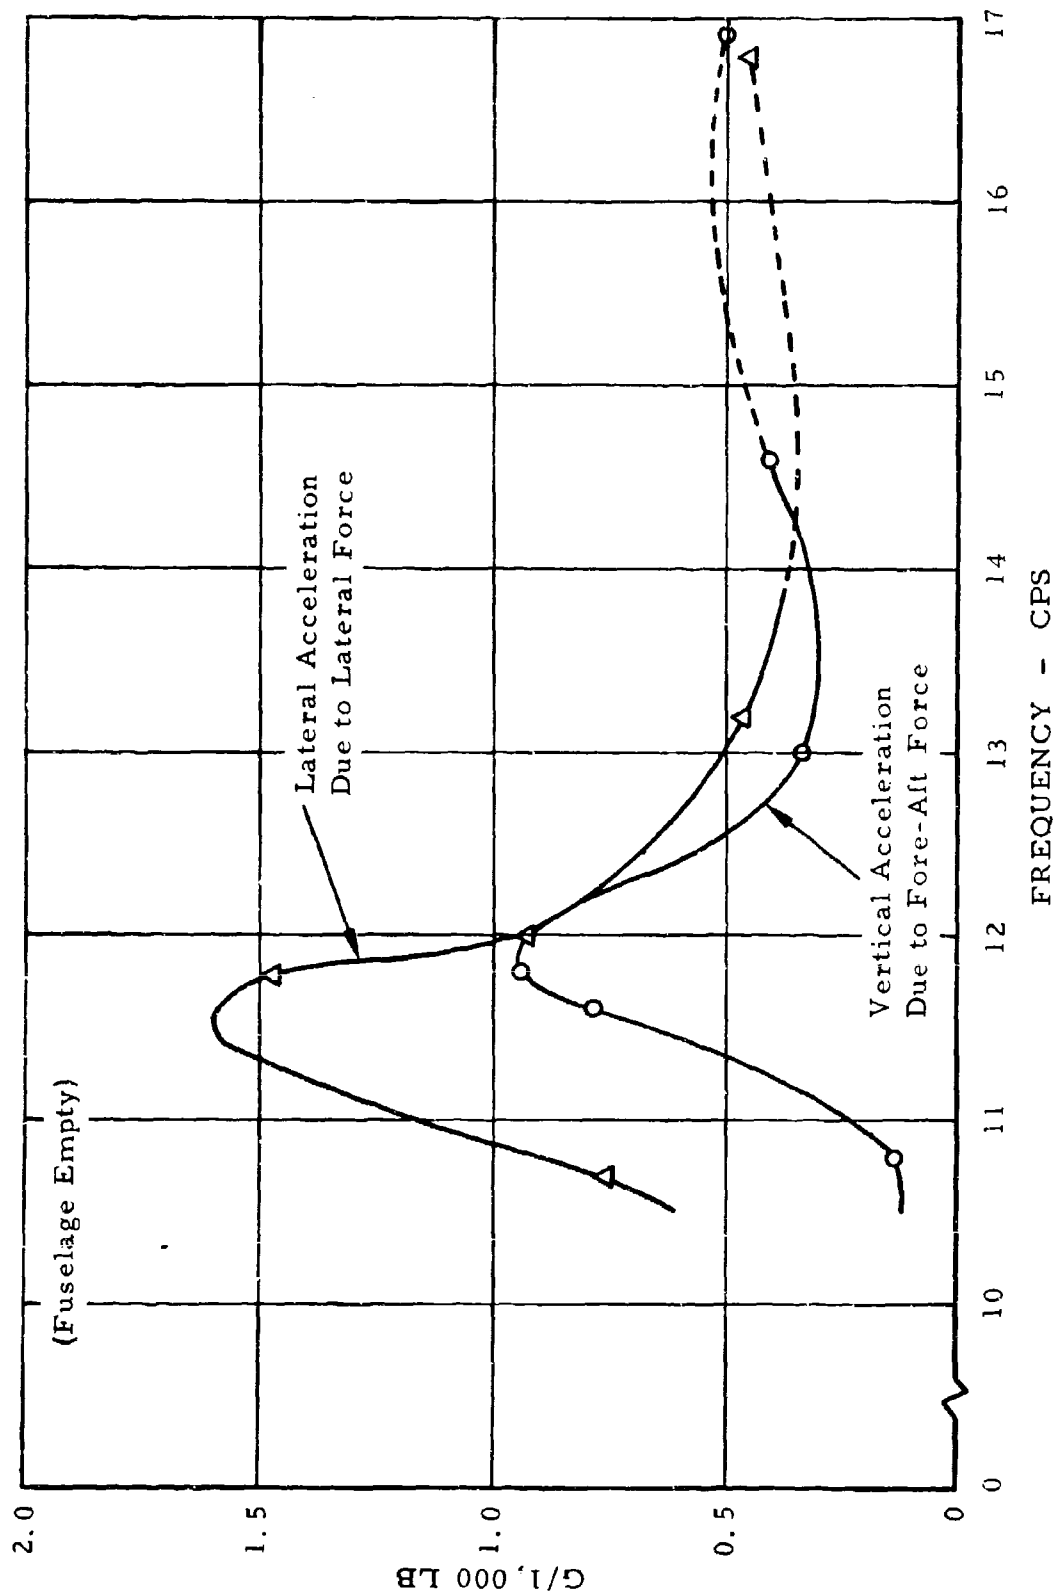
Figure 2. Pilot Acceleration Due to Force Applied to Main Rotor Shaft at Hub Gimbal Versus Frequency.

Figure 2 shows the acceleration at the pilot's seat versus frequency of applied shake force (from 6 to 30 cps) in the vertical (fore and aft force) and lateral (lateral force) directions. The same type of information is shown in Figure 3 for the tip of the horizontal stabilizer. Maximum response in this empty weight condition is seen to occur between 11.5 and 12.2 cycles per second. Since the 3-per-rev forcing frequency of the rotor is 12 cycles per second at 100-percent rotor speed (243 rpm), response of the aircraft is of interest because of the closeness to resonance.

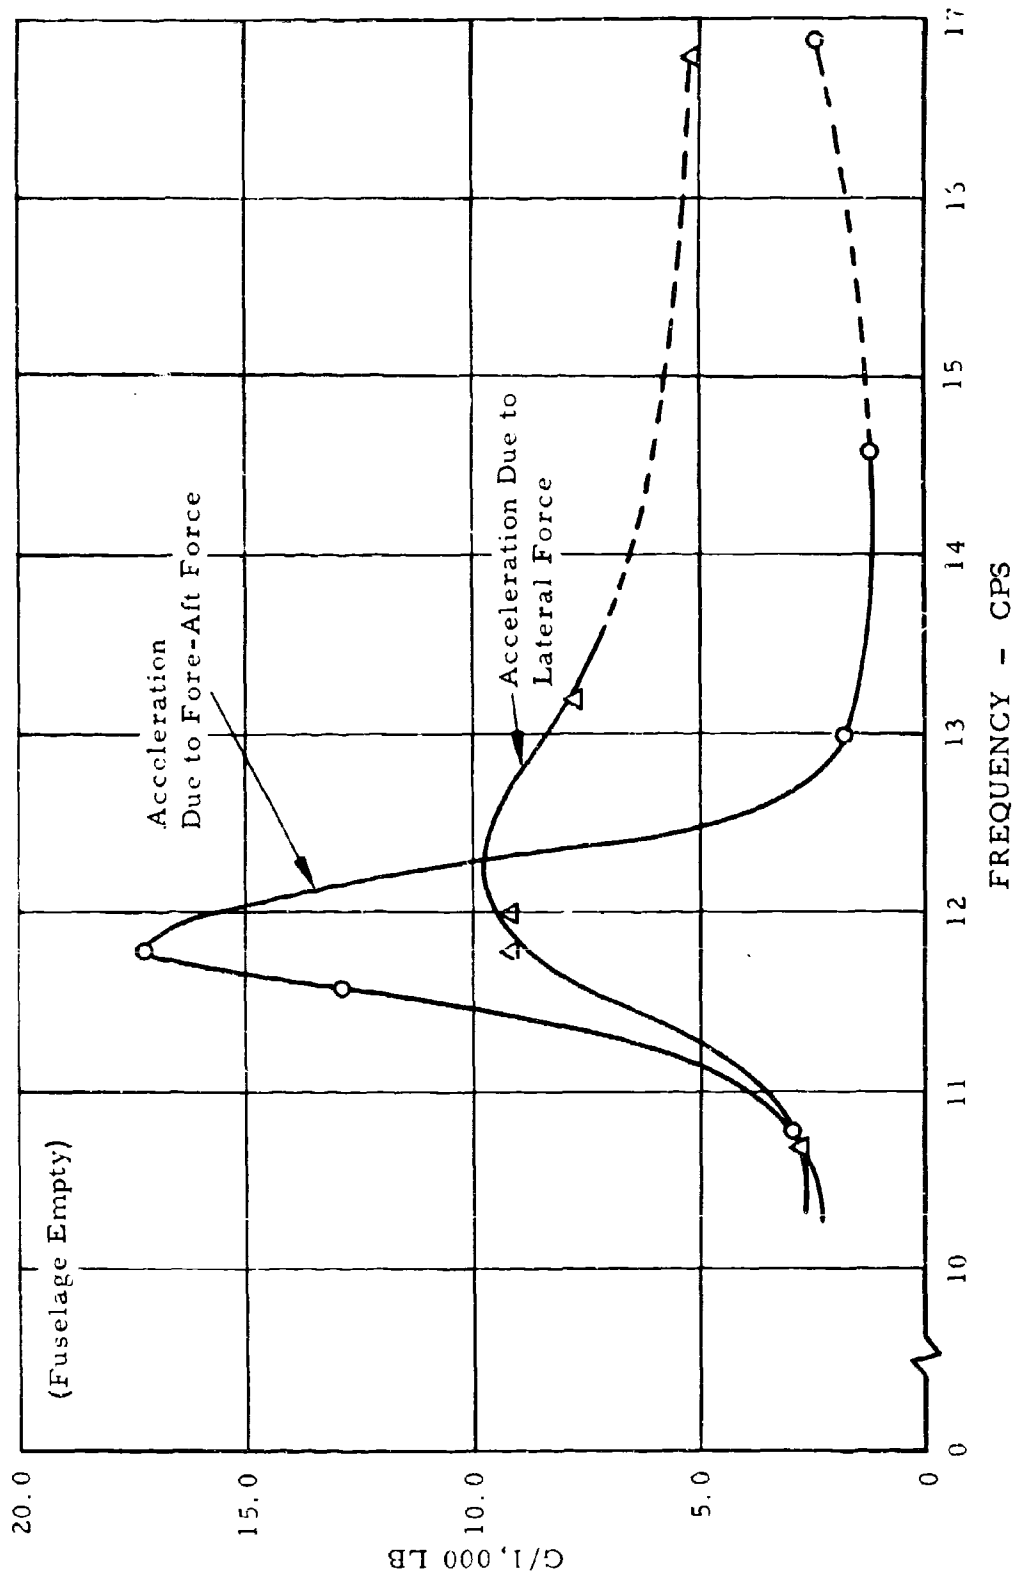
Figure 3. Normal Acceleration at Tip of Horizontal Stabilizer Due to Force Applied to Main Rotor Shaft at Hub Gimbal Versus Frequency.

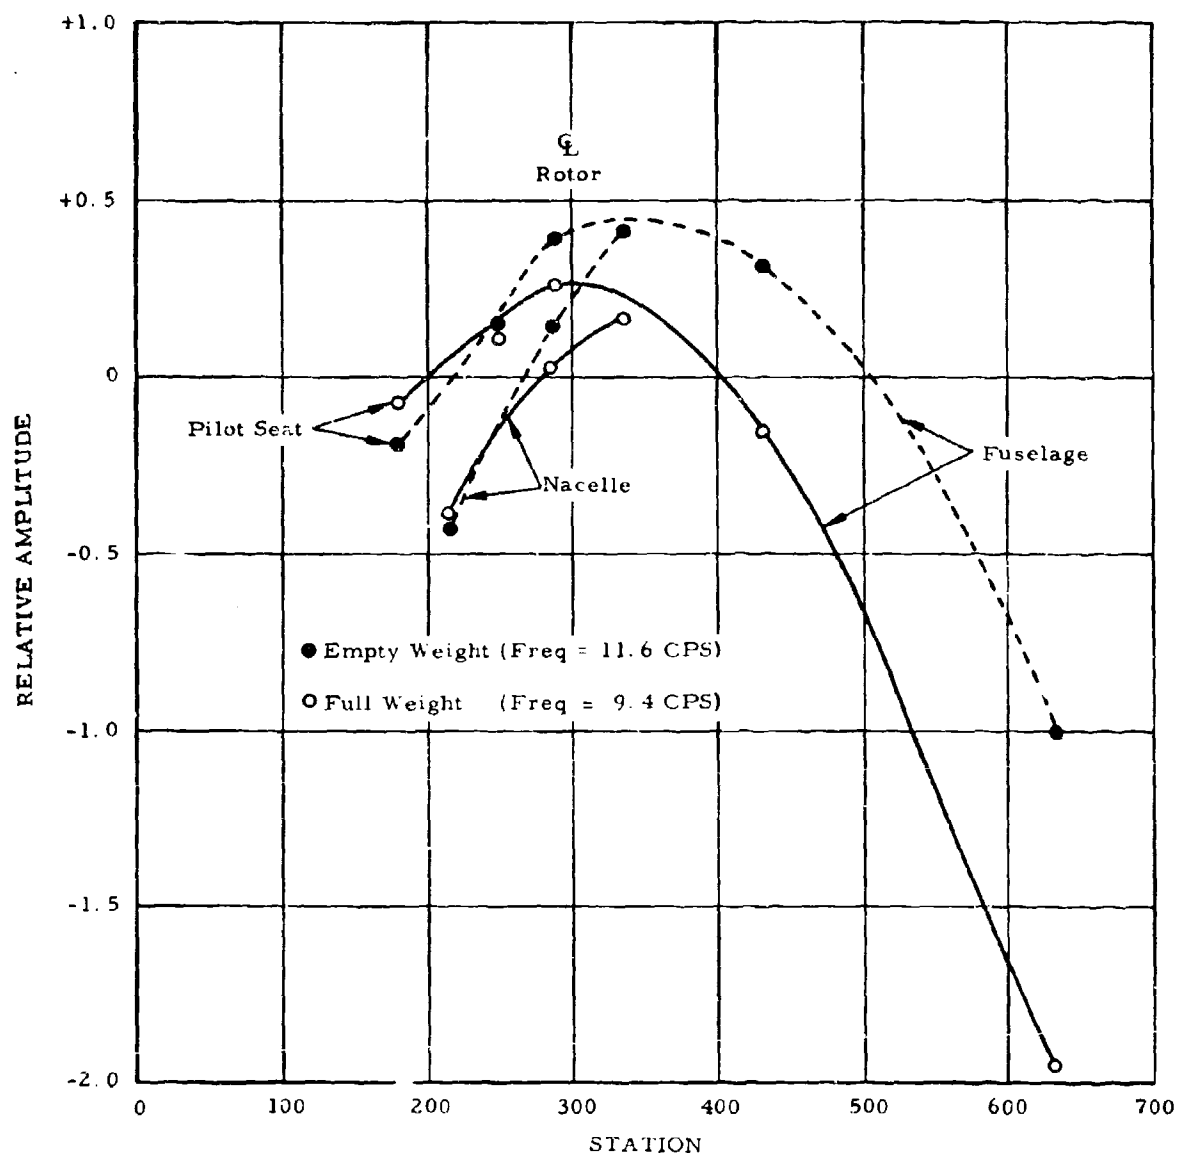
Figure 4. Fuselage Vertical Bending Versus Fuselage Station.

The measured mode shape at empty weight of the lowest fuselage and of the nacelle vertical bending mode is shown in Figure 4 for 11.6 cycles per second shake frequency. Also shown in that figure are the calculated mode shape and frequency of this fundamental mode in the full gross weight condition. It is seen that the frequency of this mode is predicted to drop to 9.4 cps, and that acceleration at the pilot's seat is reduced to approximately 40 percent. During flight tests at near design gross weight (discussed under Flight Test Results), the natural frequency of the lowest mode (detected by engine-located accelerometers) was found to be less than 10 cycles per second. This value was determined by observing engine vibration during flight at reduced rotor speed, where frequency at lowest operating rotor speed (approximately 90-percent rpm) started to approach a resonance, and appreciable engine response was noted. Flight tests at full gross weight therefore confirm the results predicted from

mode of the fuselage and engine nacelles was previously observed during fuselage shake tests (see Figure 4) where the natural frequency of the fuselage and engine nacelles was close to 3 per rev (12 cps).

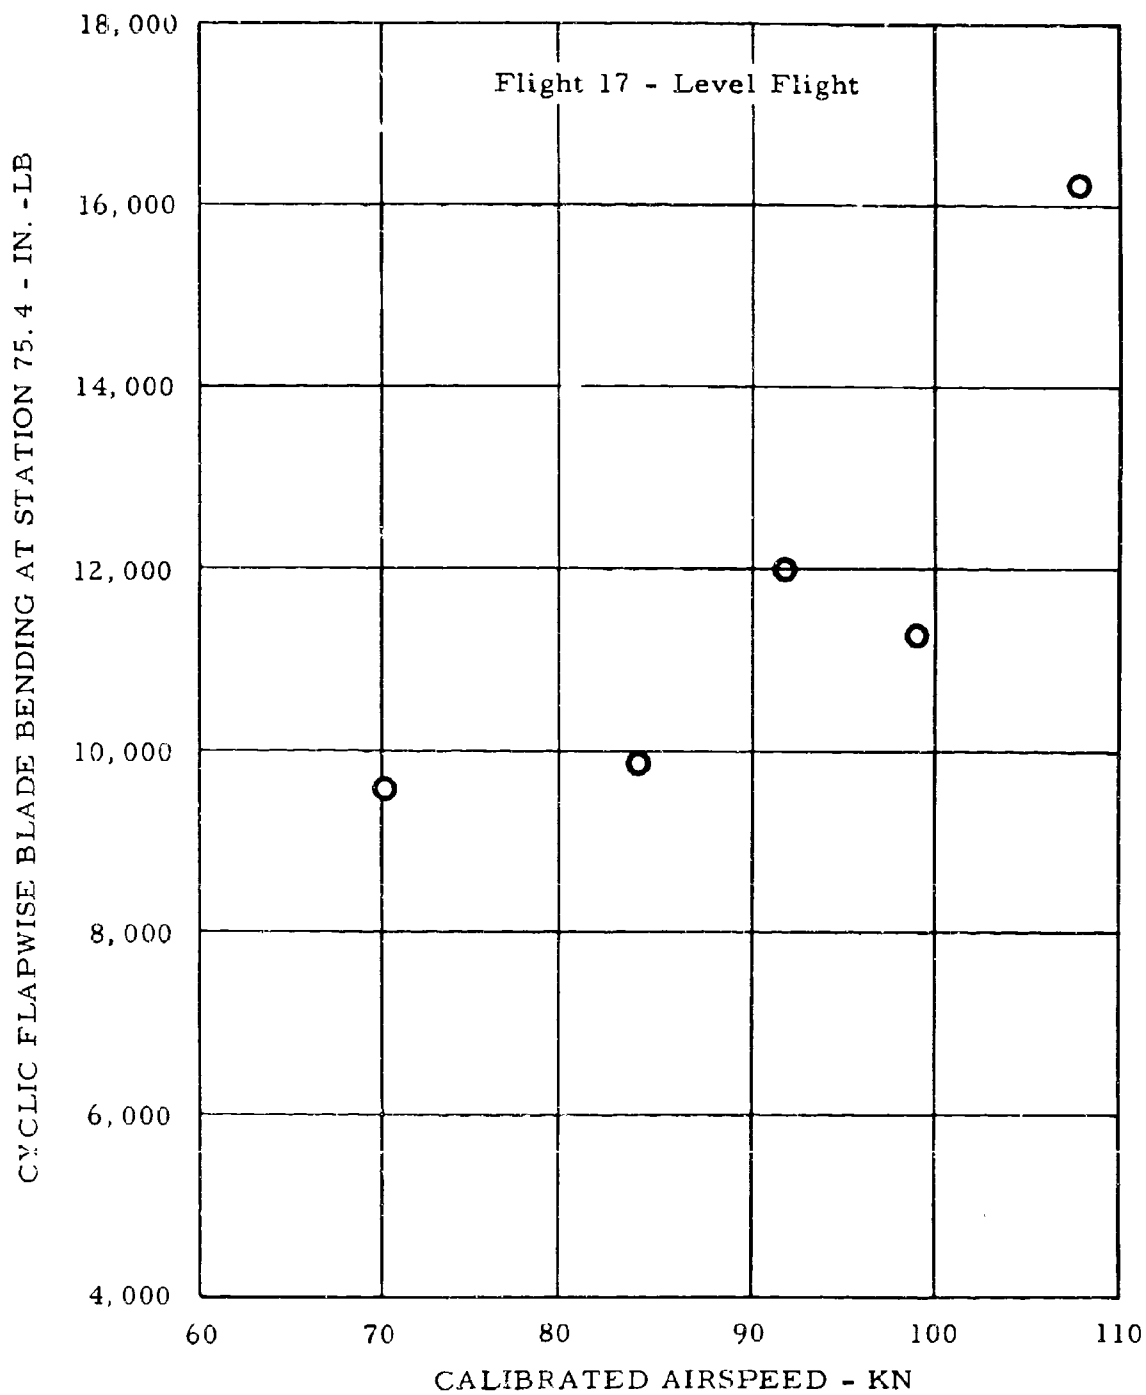
Figure 5. Cyclic Flapwise Blade Bending at Station 75.4 Versus Calibrated Airspeed.

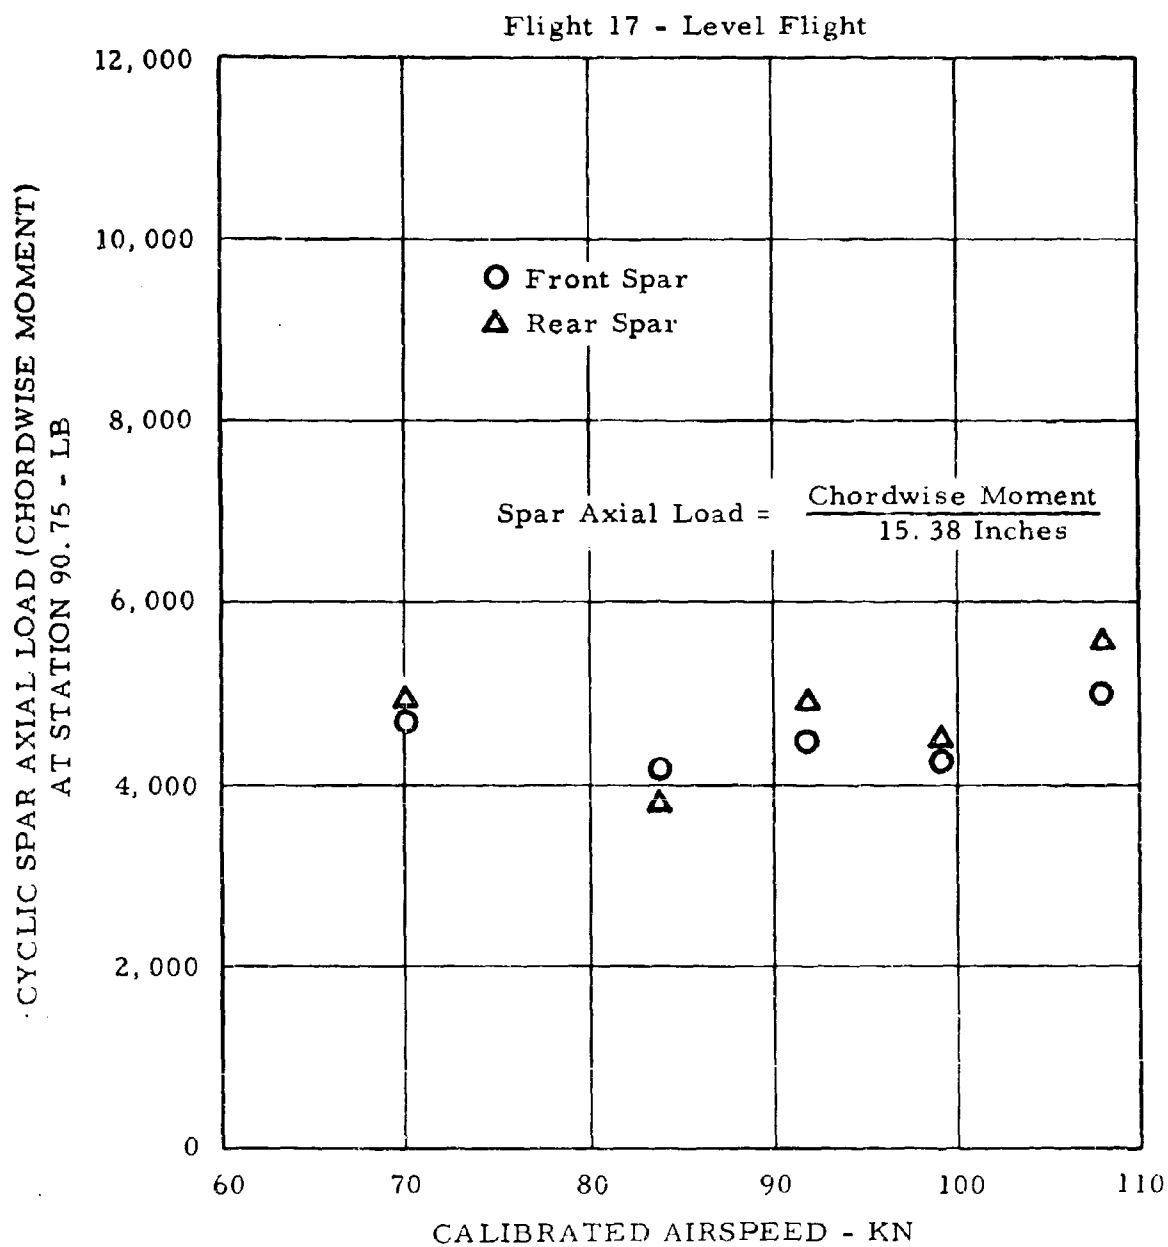
Figure 6. Cyclic Spar Axial Load (Chordwise Moment) at Station 90.75 Versus Calibrated Airspeed.

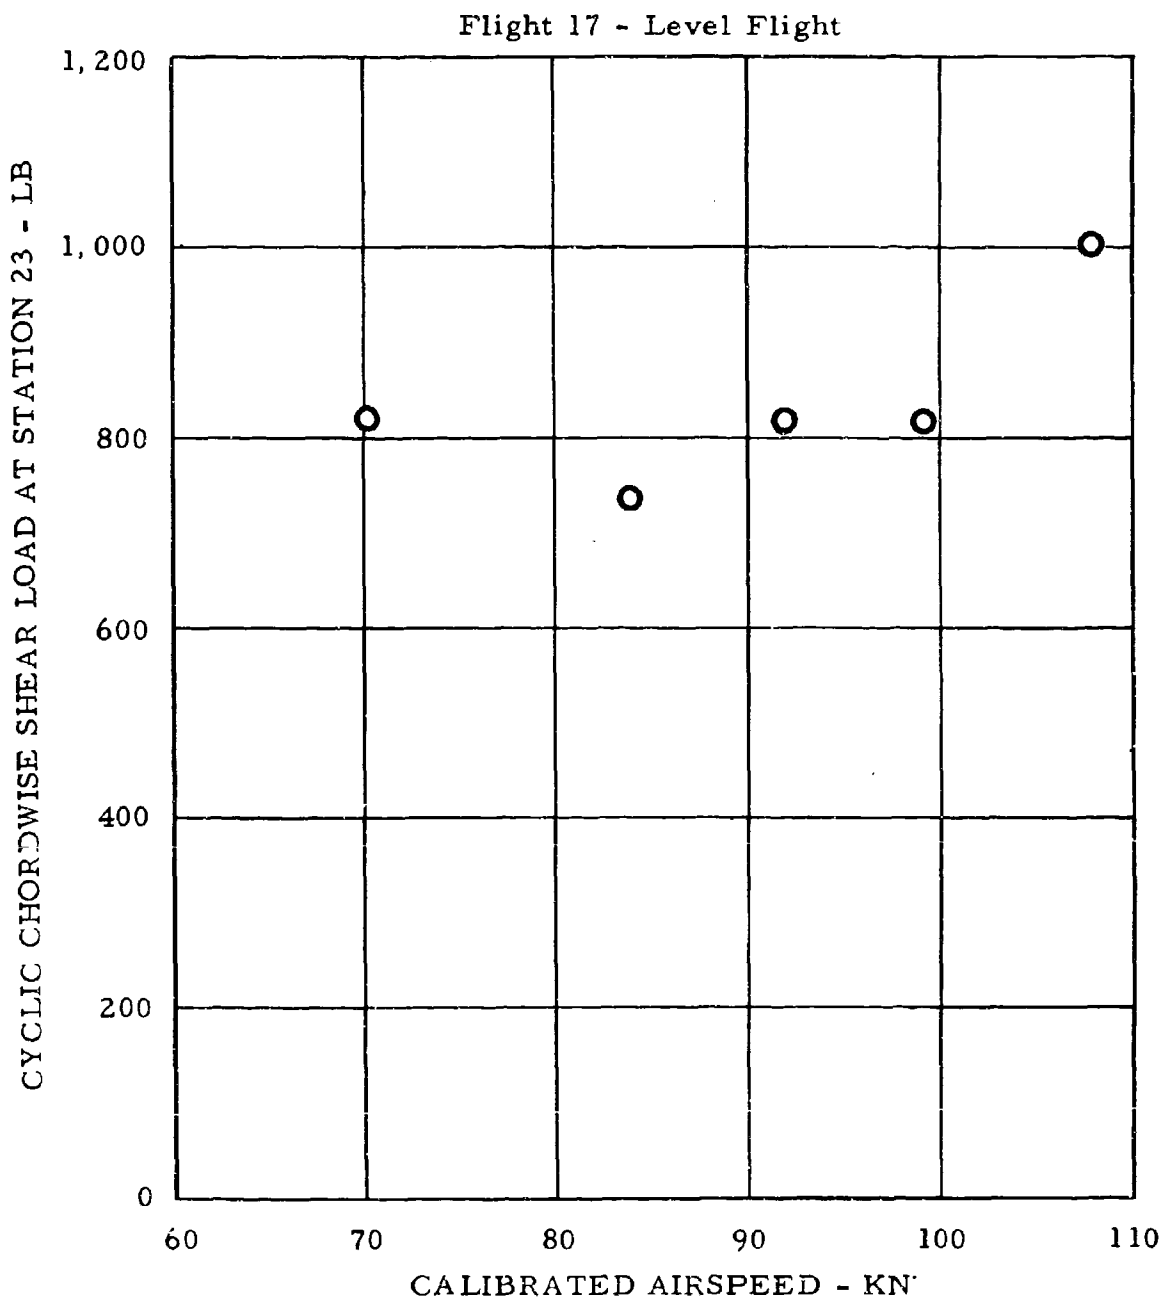
Figure 7. Cyclic Chordwise Shear Load at Station 23 Versus Calibrated Airspeed.

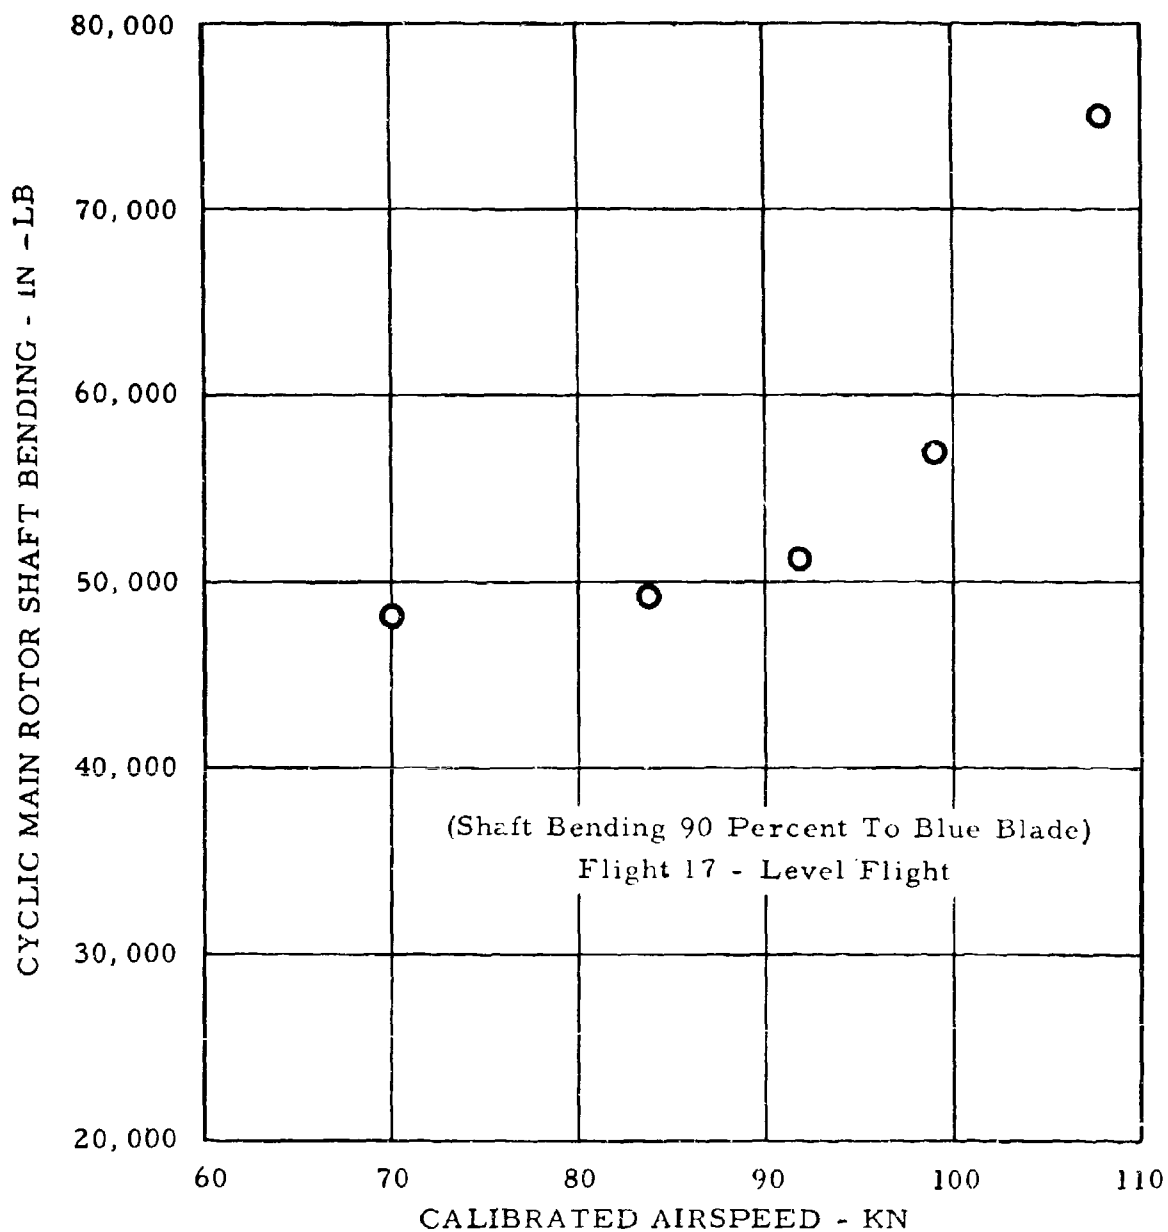
Figure 8. Cyclic Main Rotor Shaft Bending Versus Calibrated Airspeed.

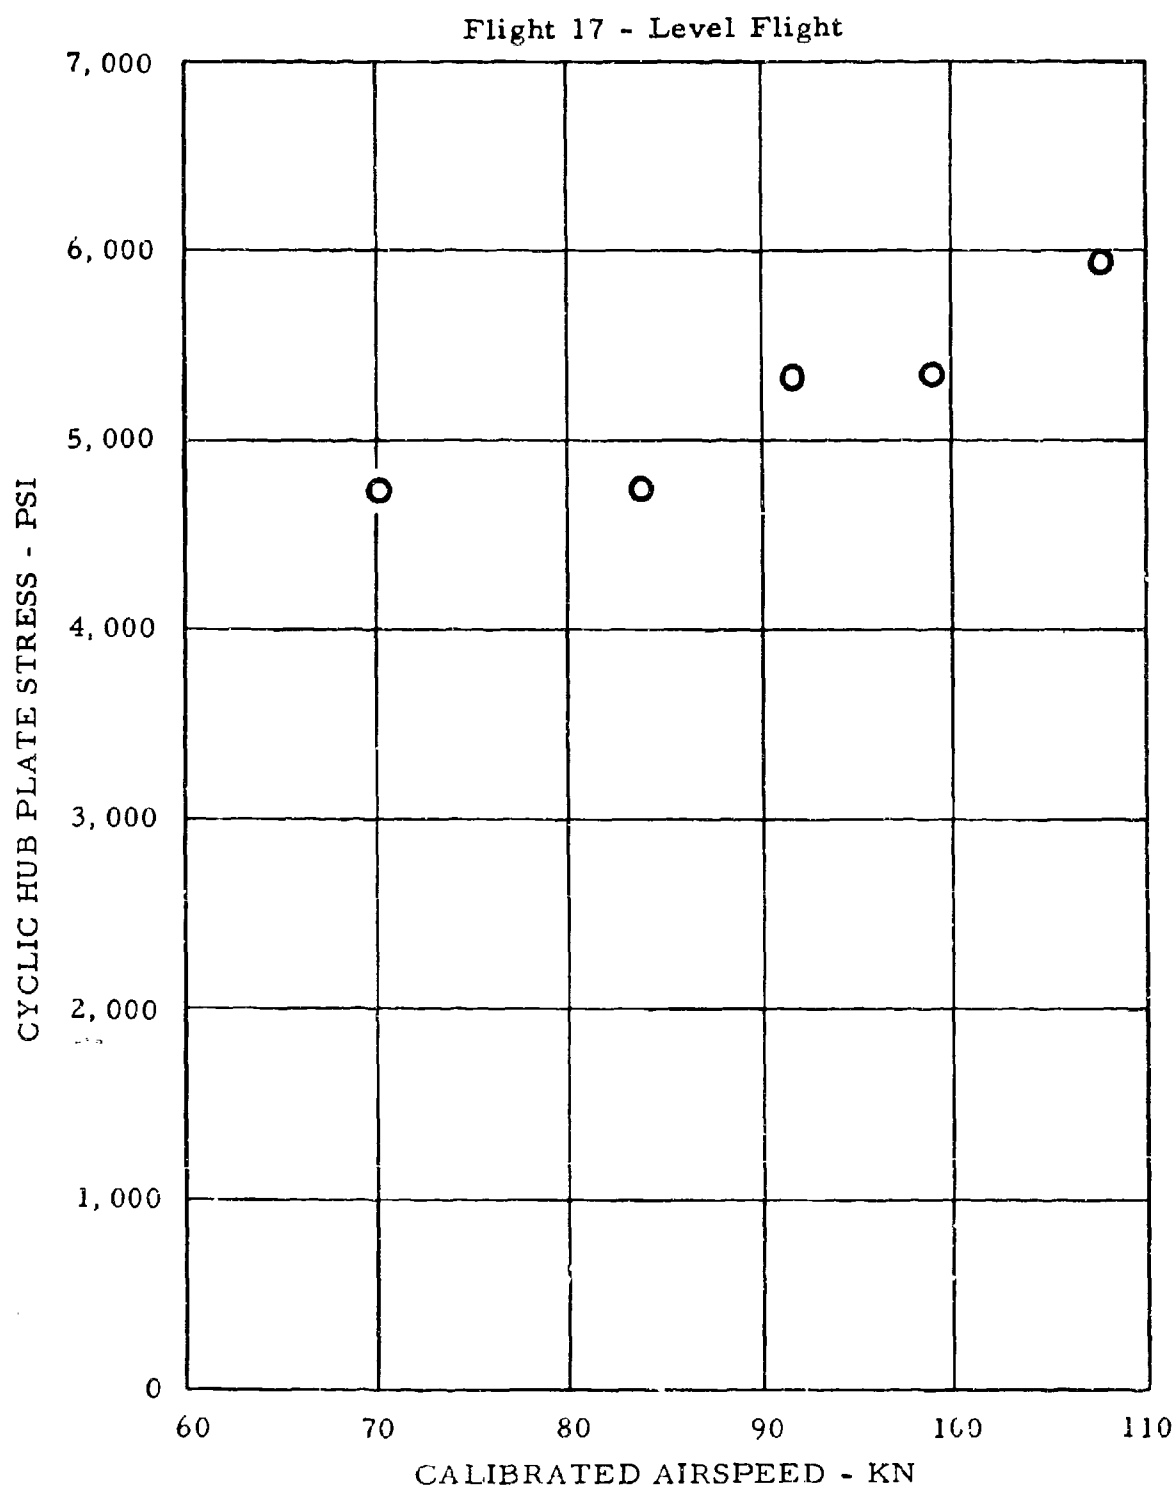
Figure 9. Cyclic Hub Plate Stress Versus Calibrated Airspeed.

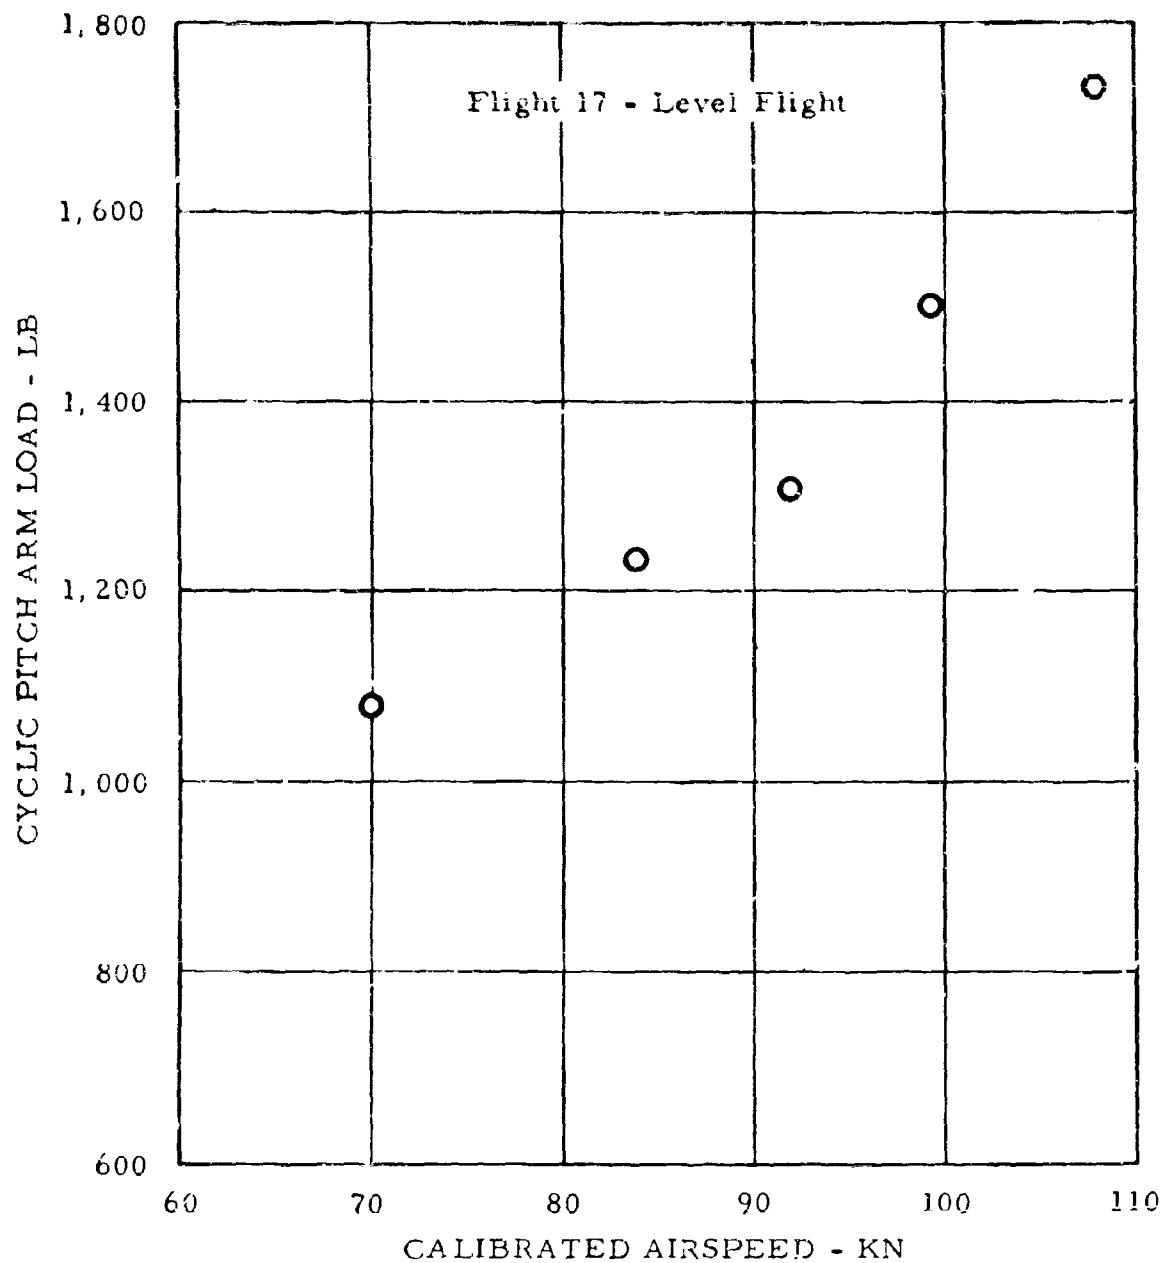
Figure 10. Cyclic Pitch Arm Load Versus Calibrated Airspeed.

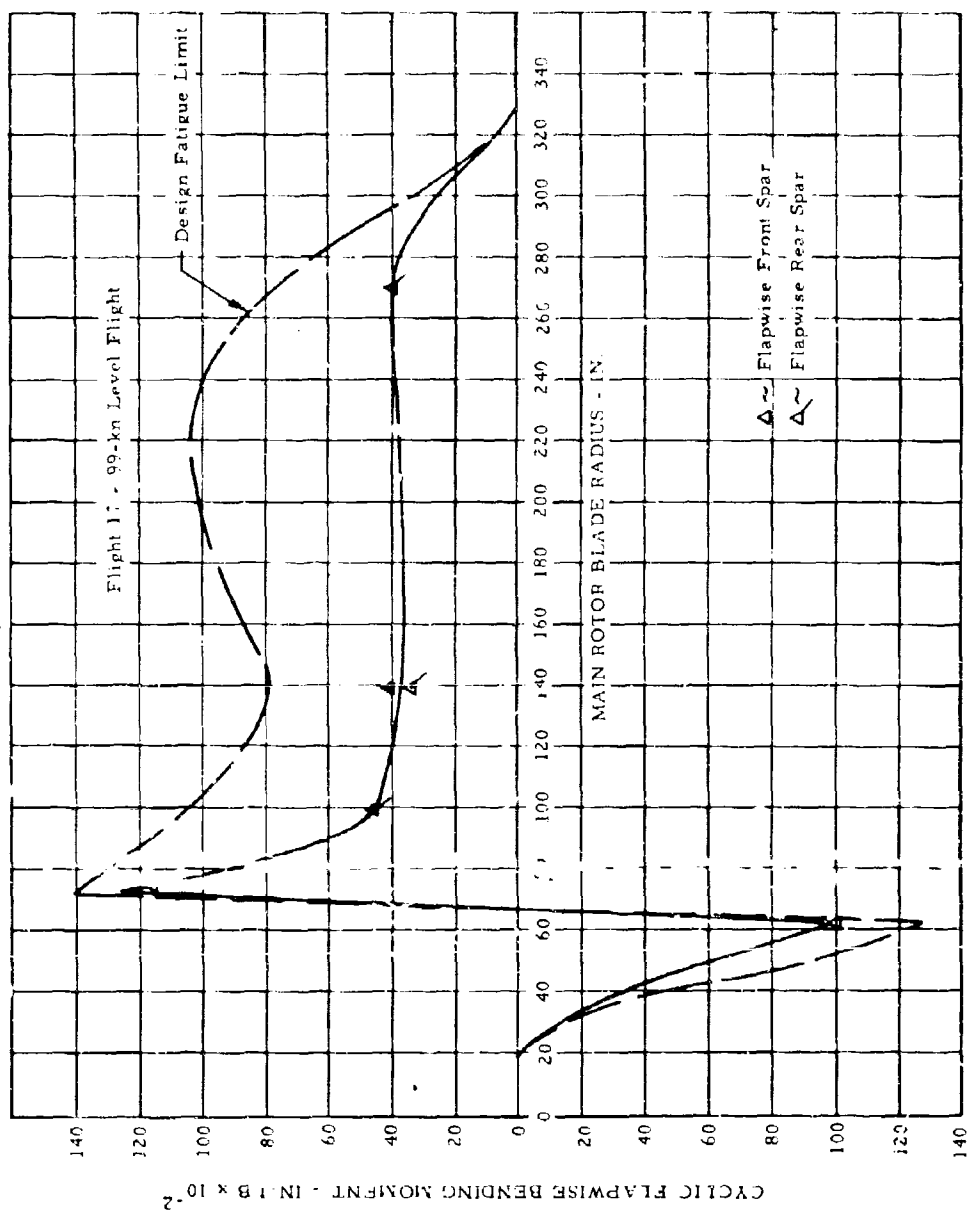
Figure 11. Cyclic Flapwise Bending Moment Versus Main Rotor Blade Radius.

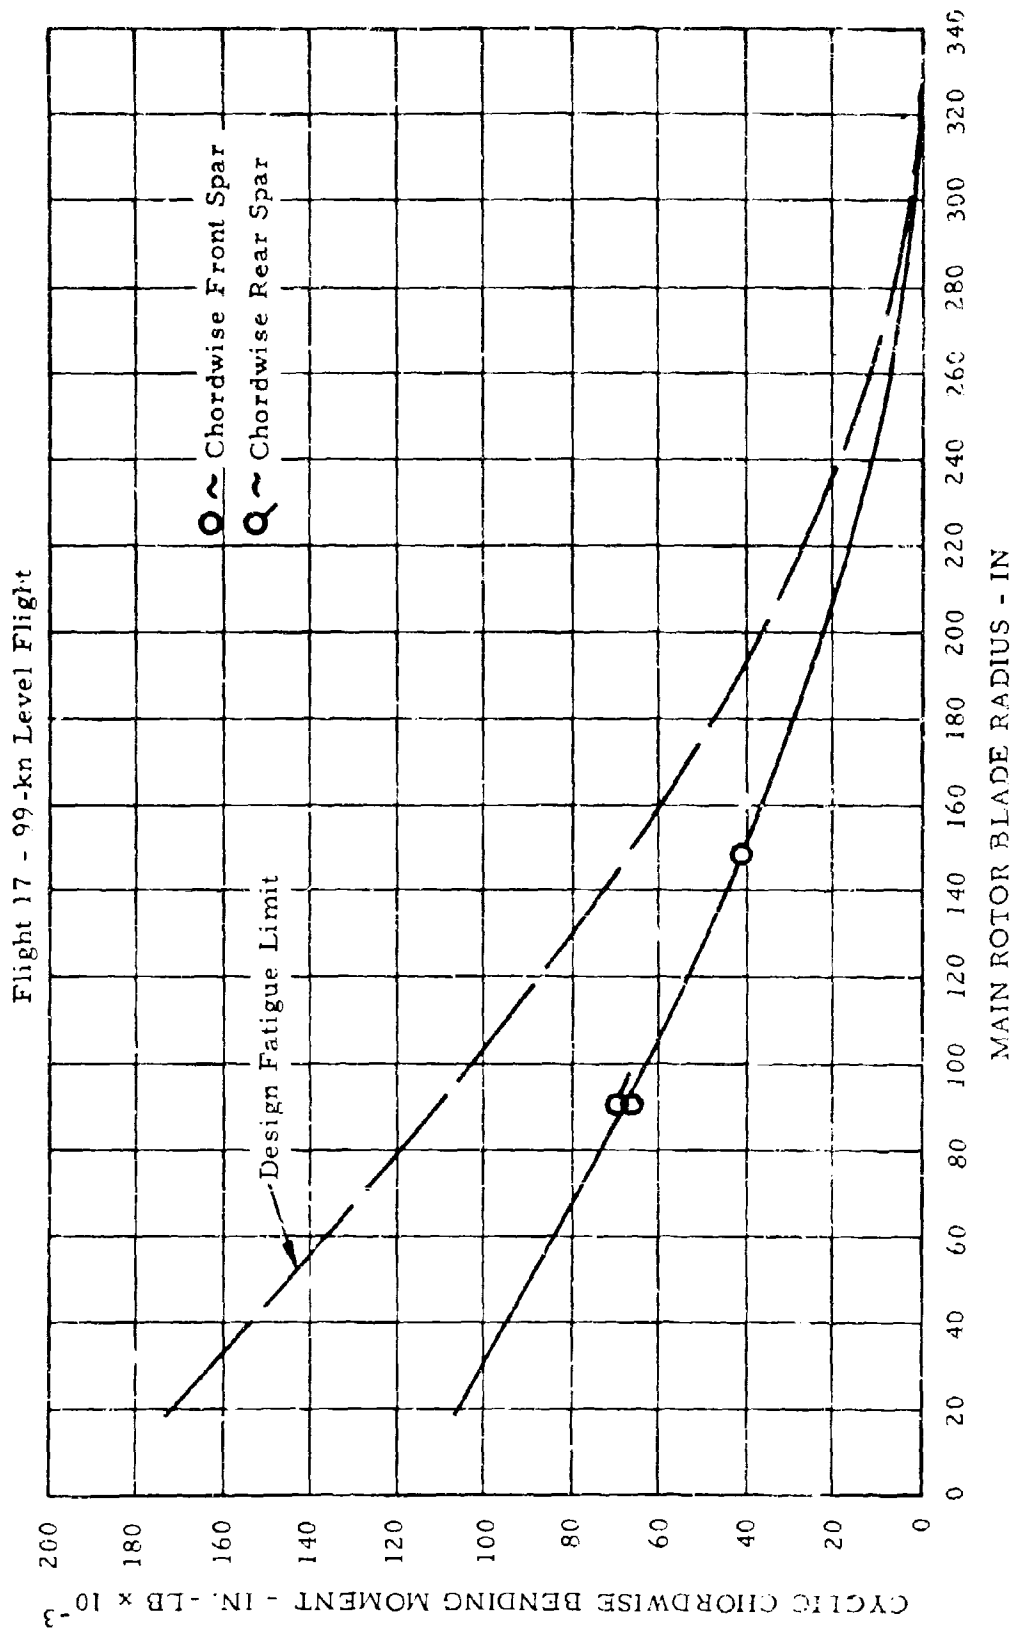
Figure 12. Cyclic Chordwise Bending Moment Versus Main Rotor Blade Radius.

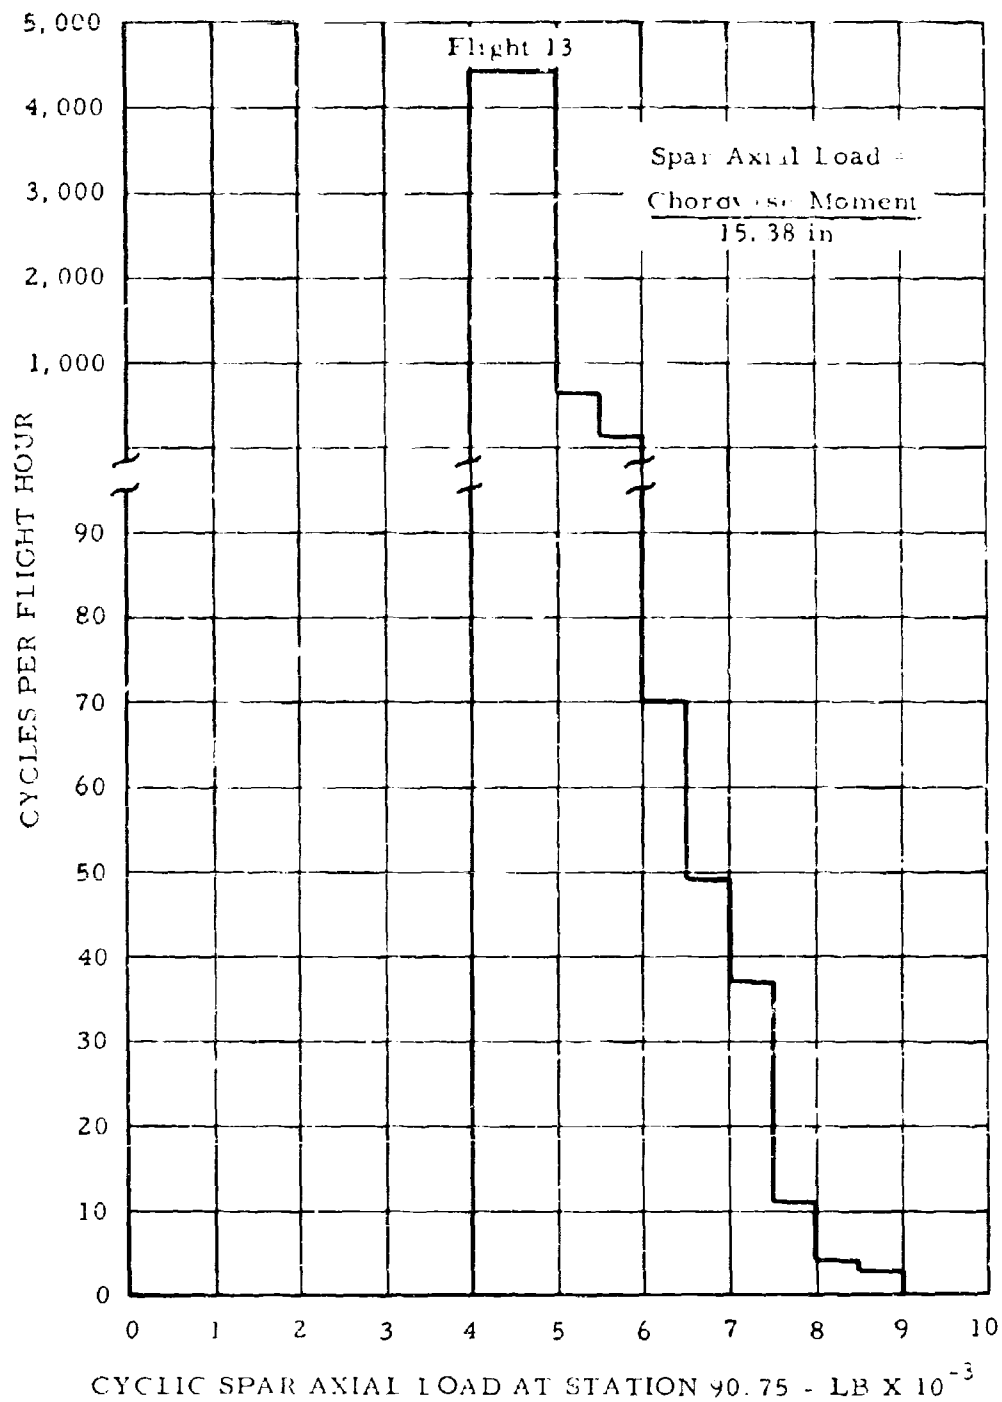
Figure 13. Cycles per Flight Hour Versus Cyclic Spar Axial Load at Station 90.75.

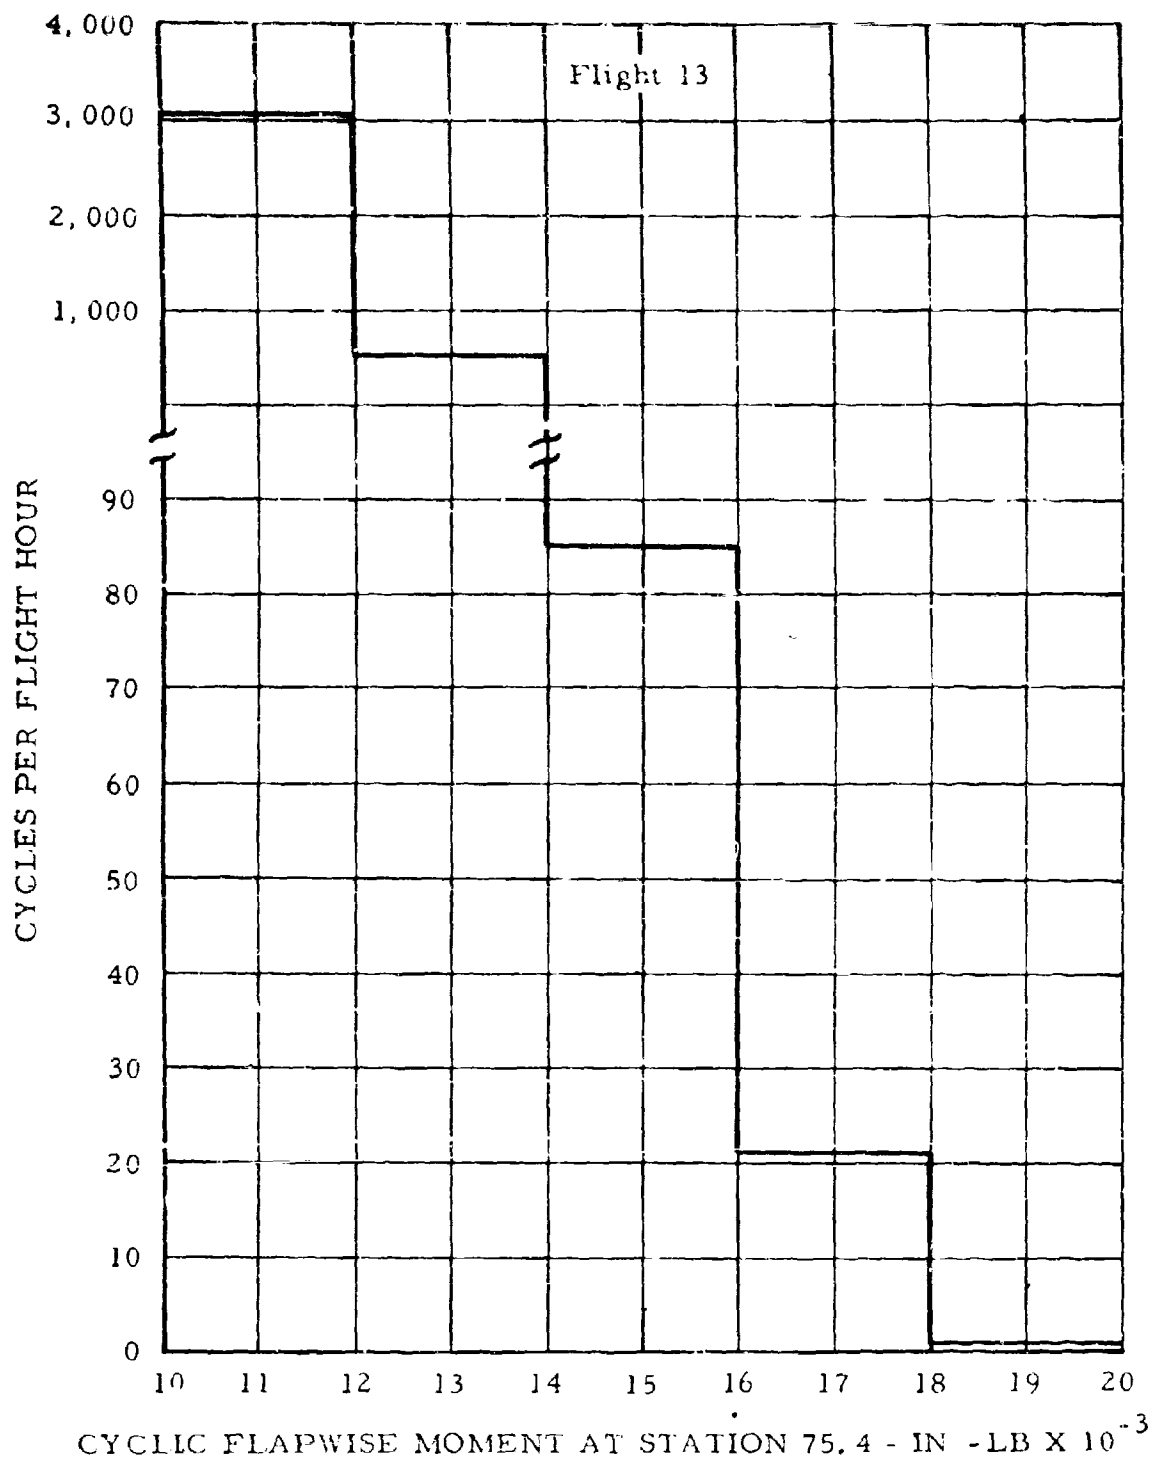
Figure 14. Cycles Per Flight Hour Versus Flapwise Blade Bending at Station 75.4.

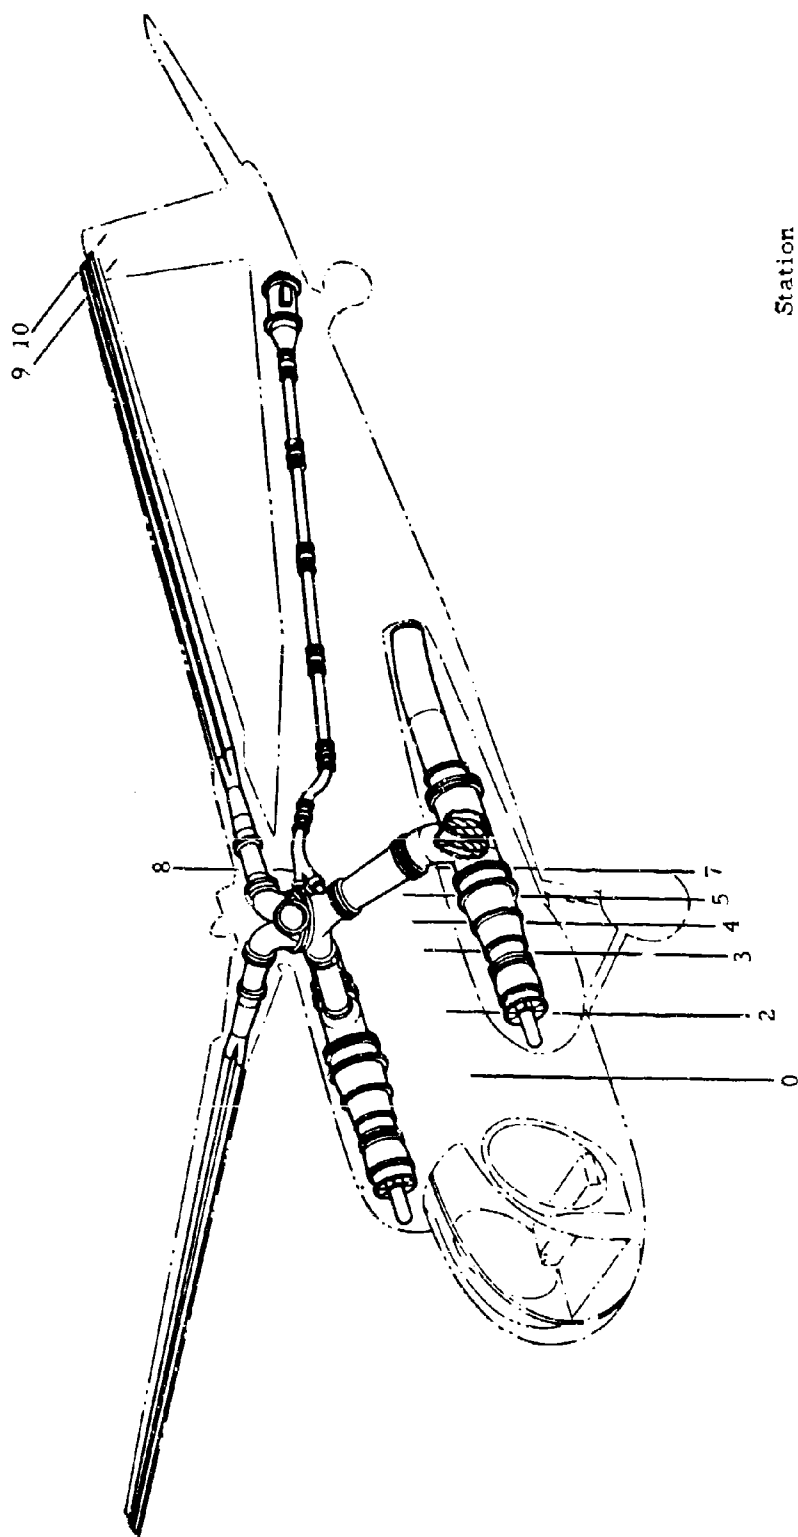
Station	
0	Ambient
2	Compressor Inlet
3	Compressor Discharge
4	Turbine Inlet
5	Turbine Discharge
7	Engine Exhaust
8	Blade Root
9	Blade Tip Cascade Inlet
10	Cascade Exit

Figure 17. Propulsion System Station Locations.

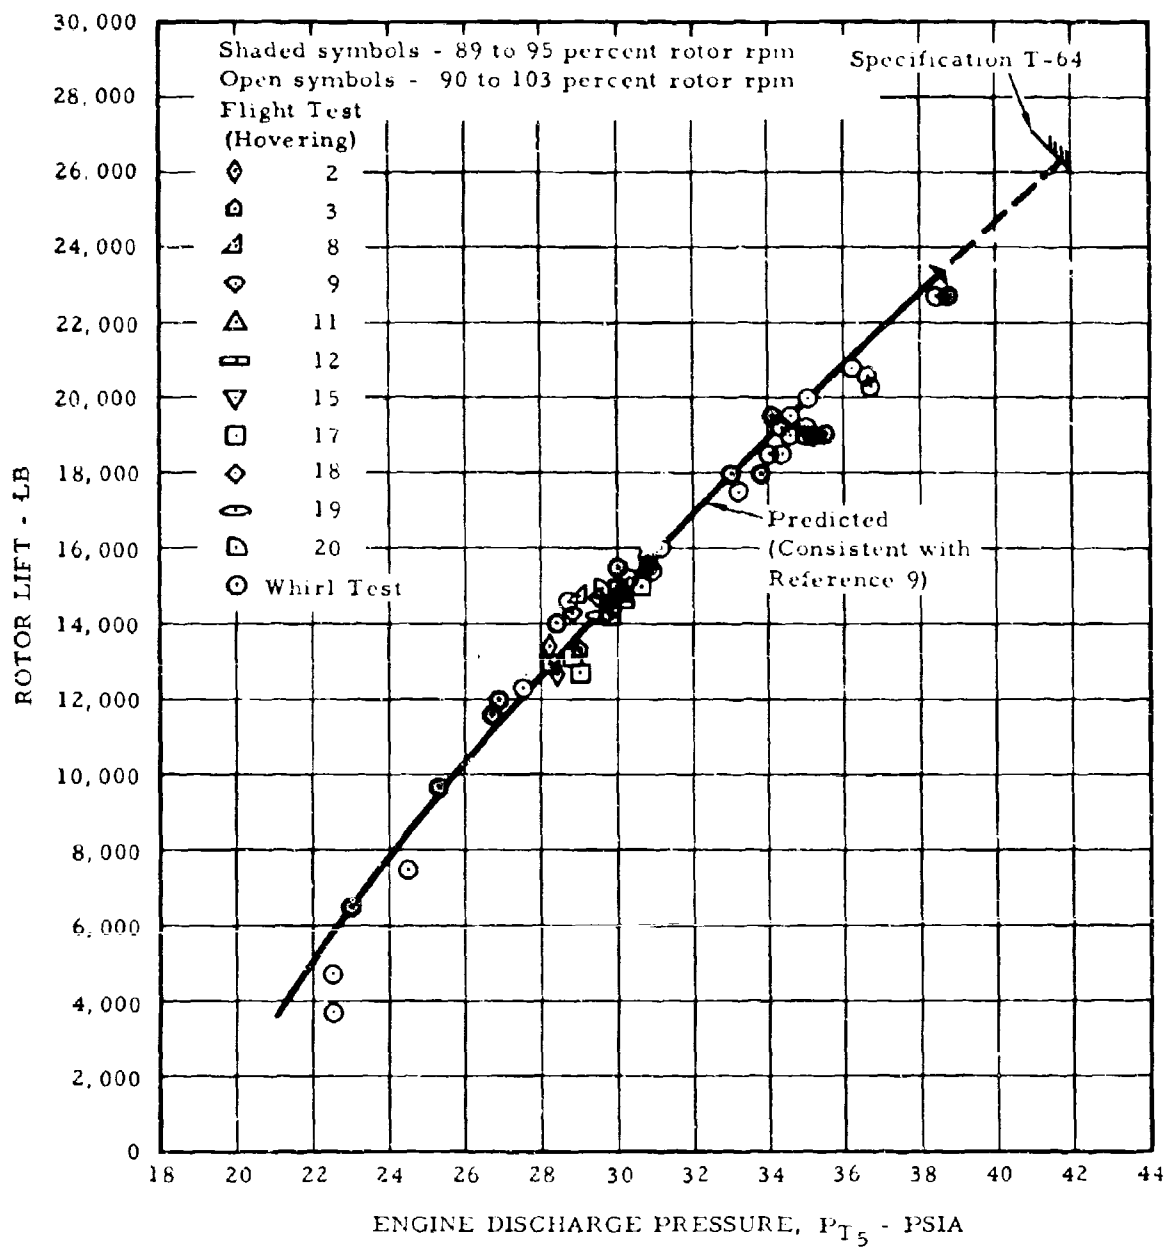
Figure 18. Rotor Lift Versus Engine Discharge Pressure.
